Ice/Frost/Debris Assessment For Space Shuttle Mission STS-27R

(NASA-TM-102144) ICE/FROST/DEBRIS
ASSESSMENT FOR SPACE SHUTTLE MISSION
STS-27R, DECEMBER 2, 1988 (NASA) 200 p
CSCI 22B

ICE/FROST/DEBRIS ASSESSMENT
FOR
SPACE SHUTTLE MISSION
STS-27R
DECEMBER 2, 1988

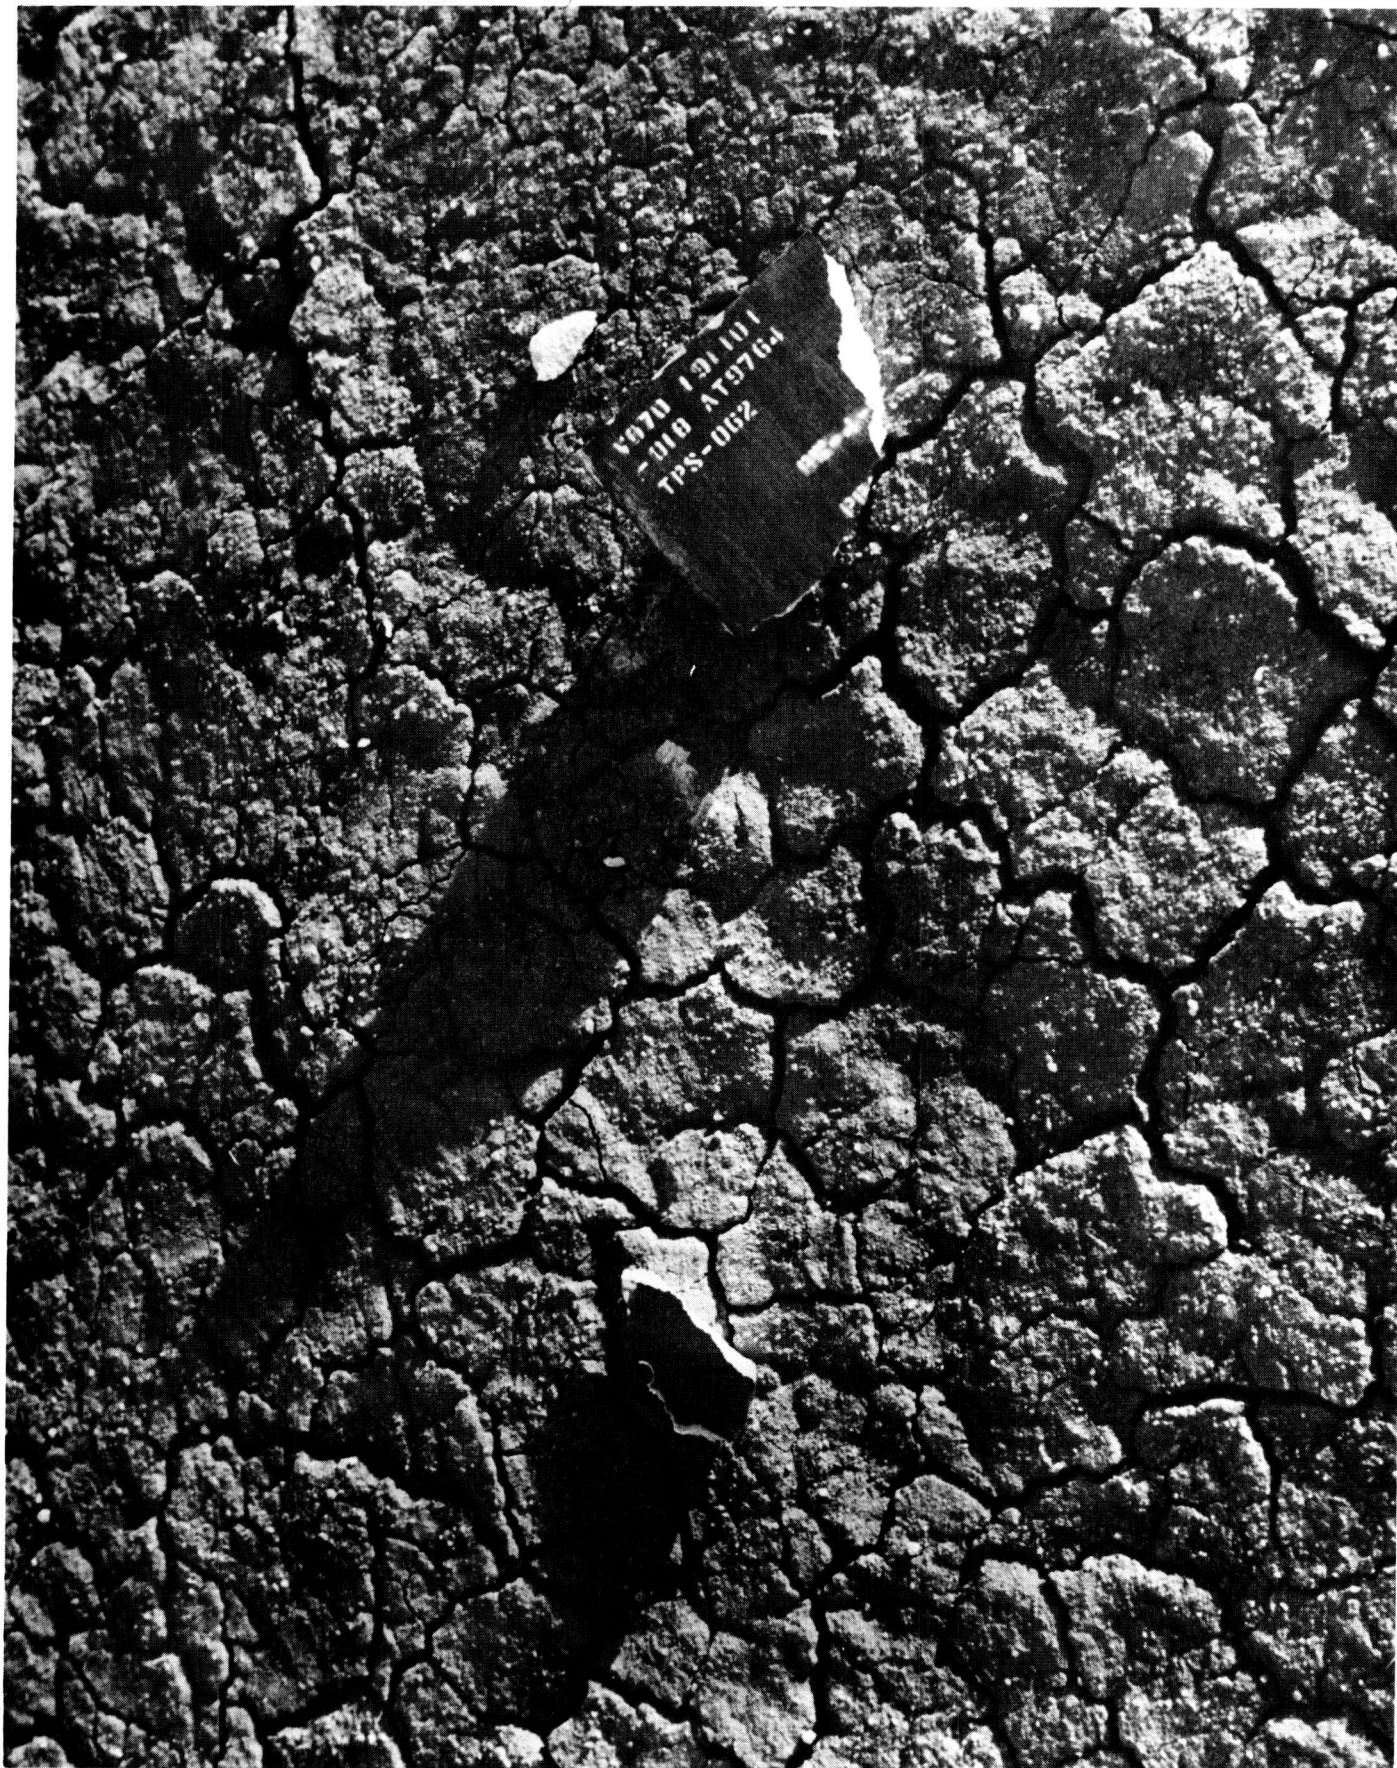
FRAGMENTS OF OUTBOARD FORWARD CORNER TILE FROM RH MLG DOOR
FOUND ON RUNWAY APPROACH THRESHOLD AFTER LANDING

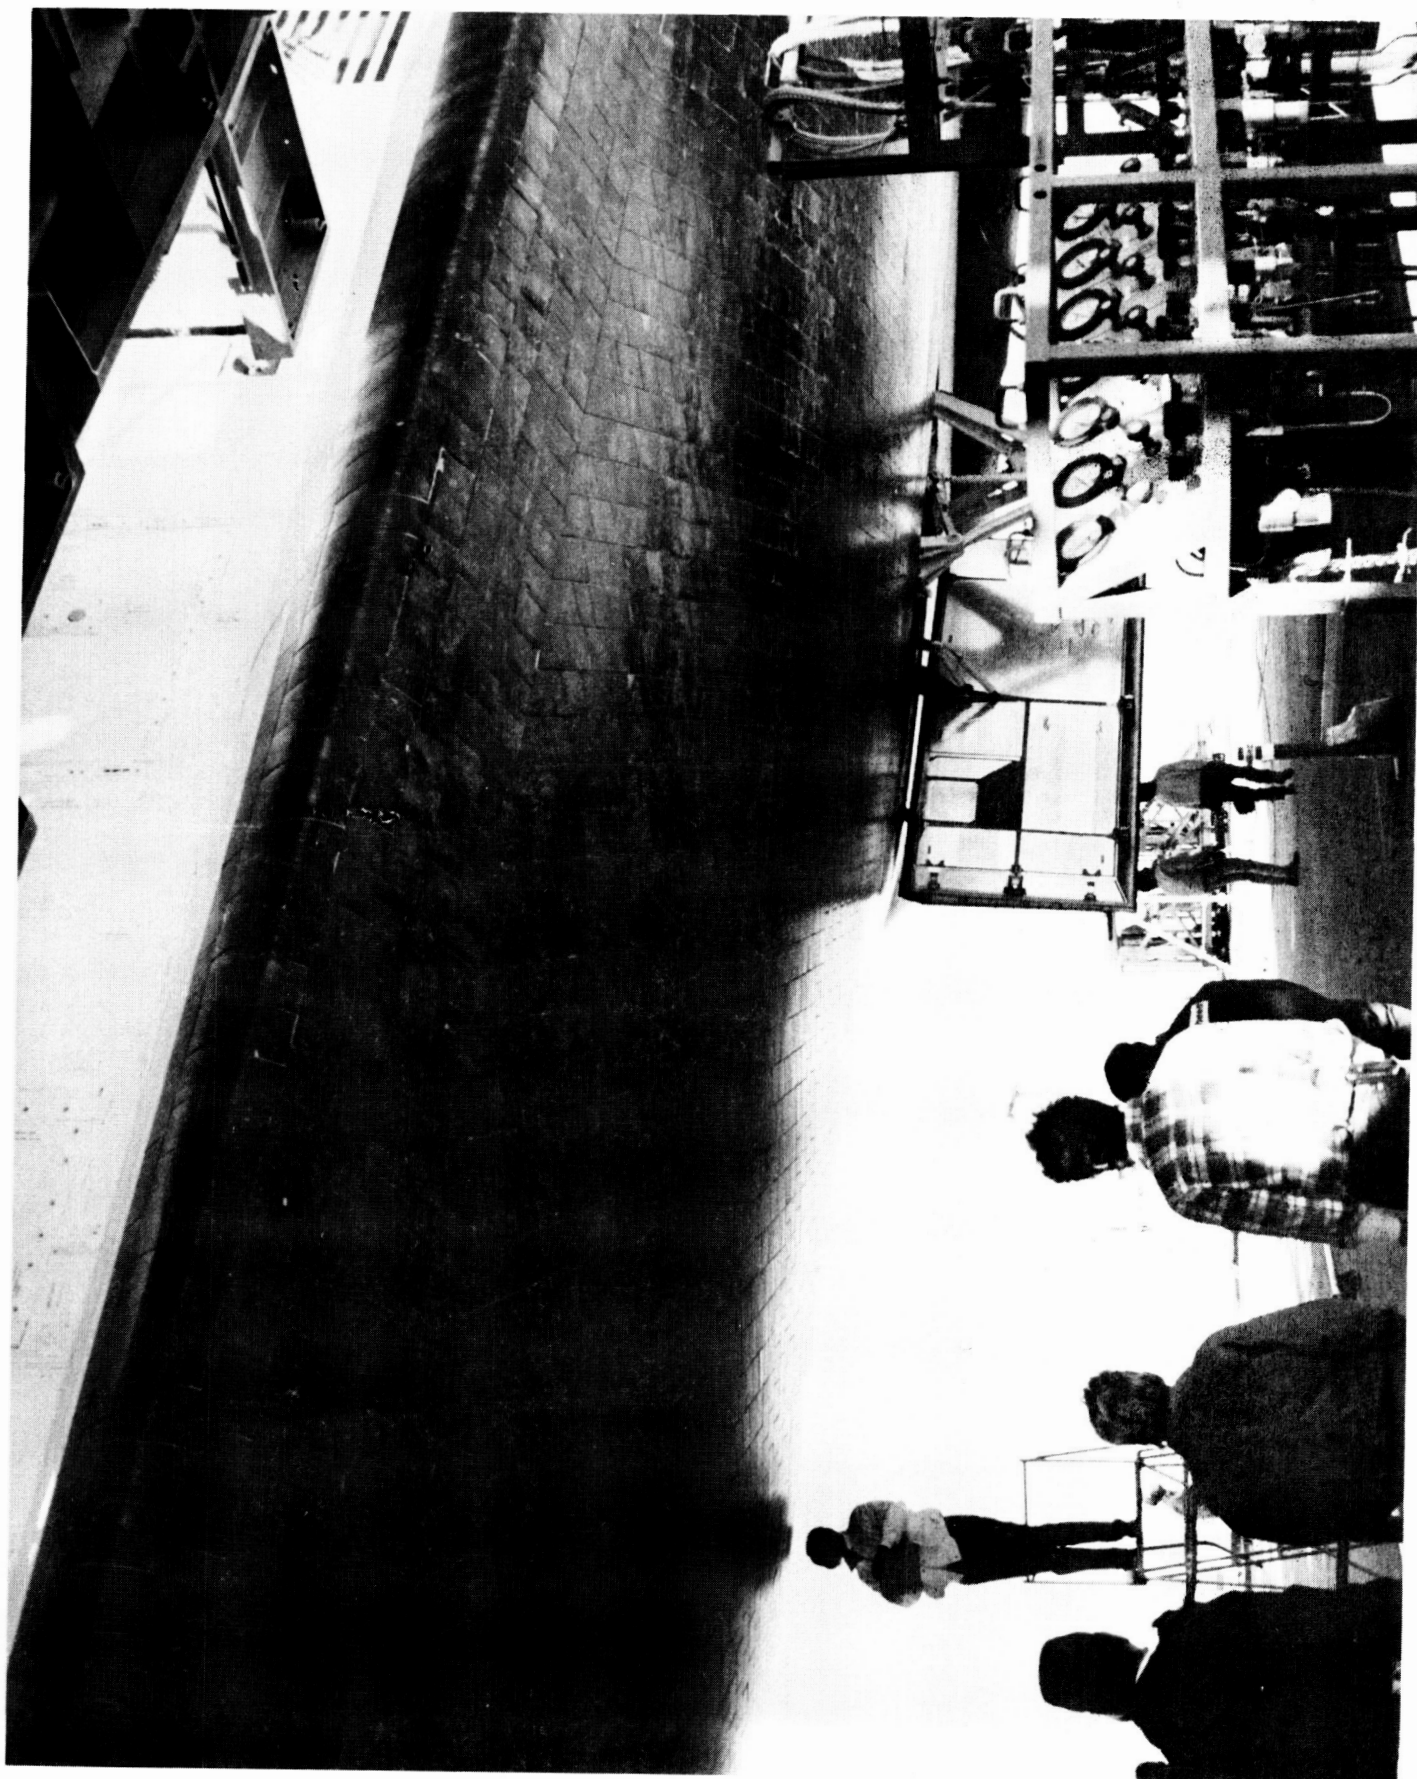
MINIMAL DAMAGE ON LH FORWARD LOWER FUSELAGE AND CHINE AREA.

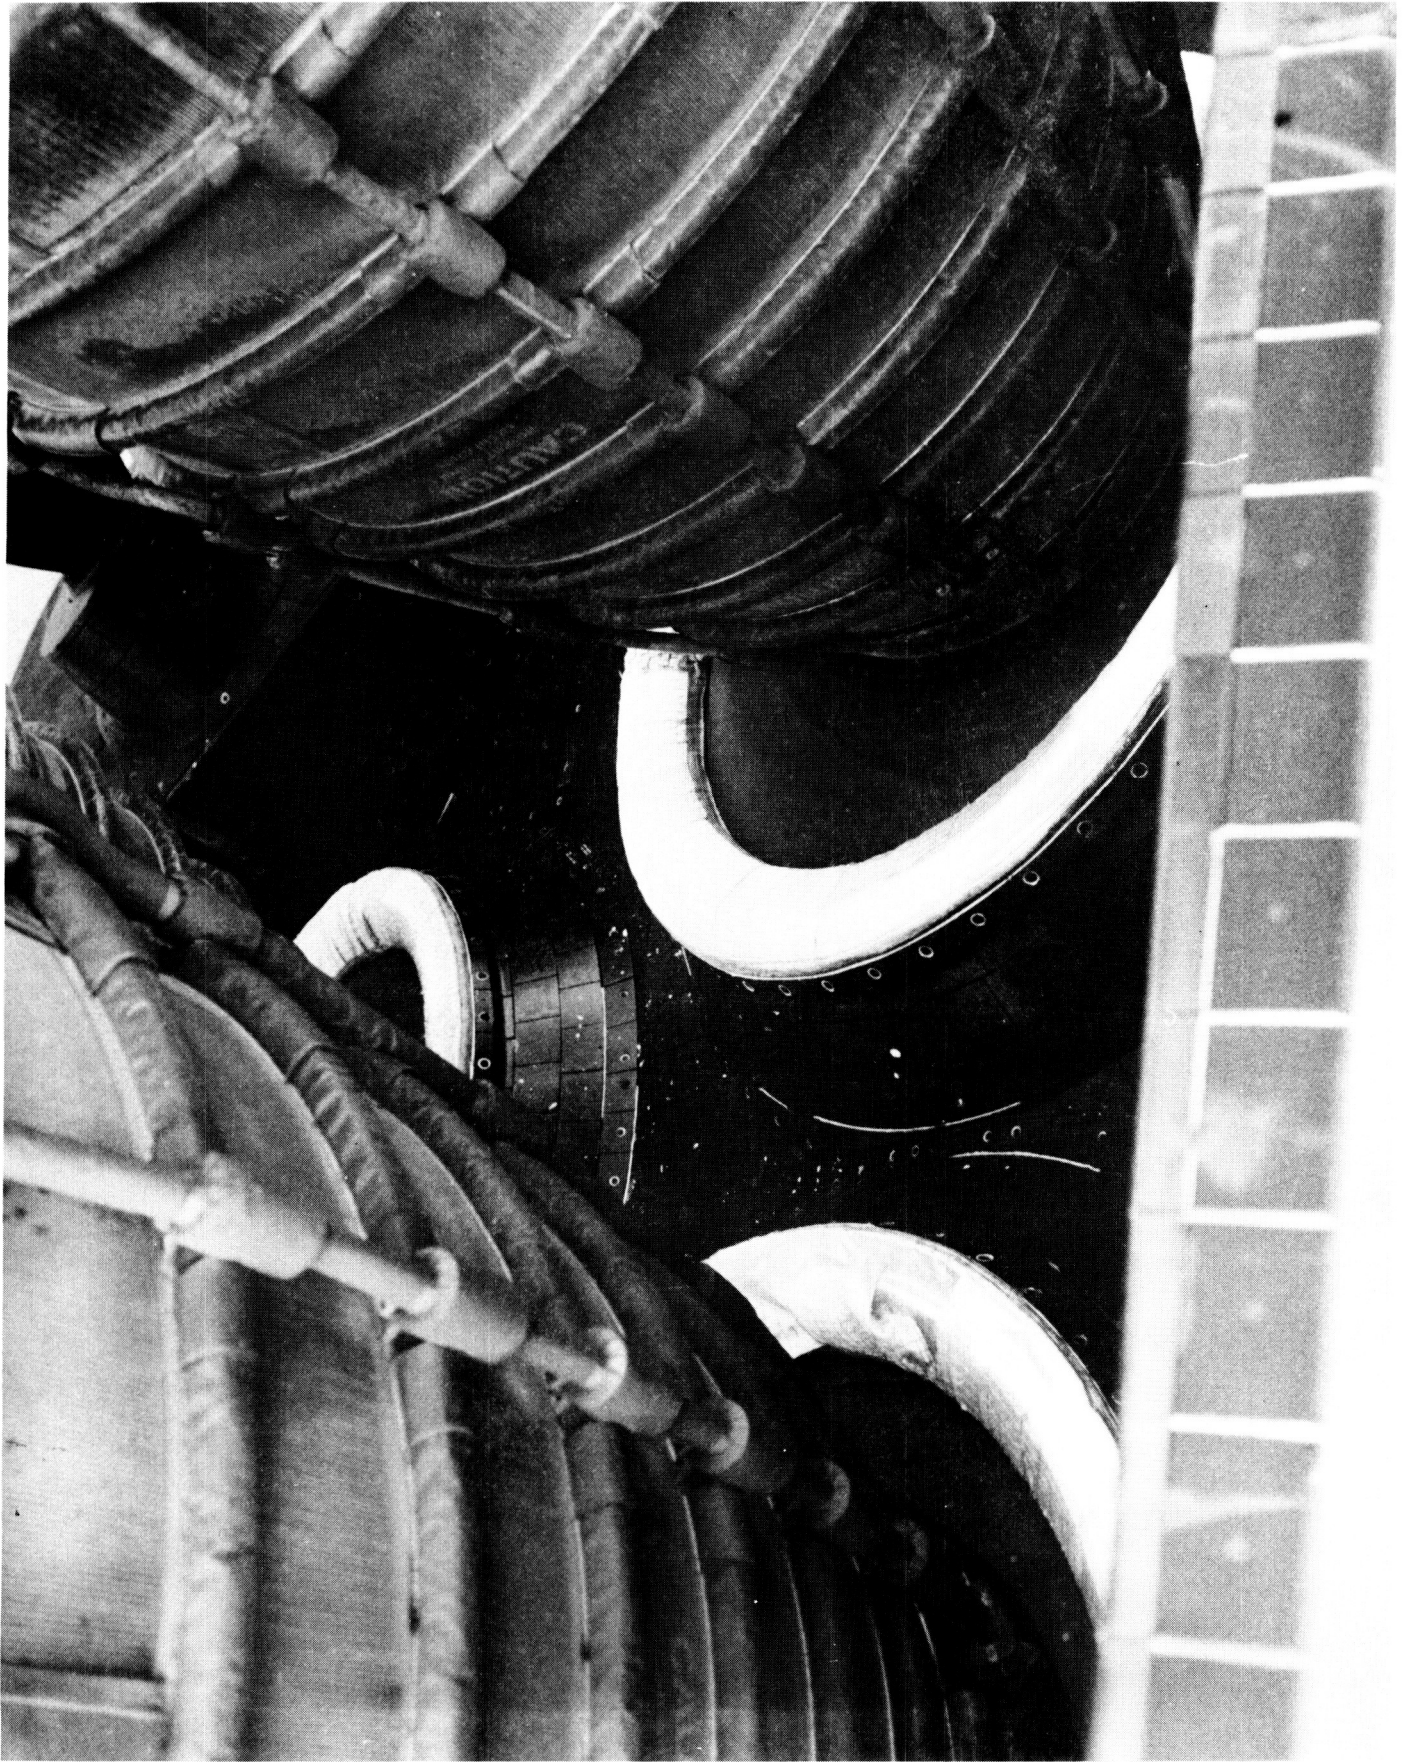
TYPICAL TILE 'DINGS' ON BASE HEAT SHIELD

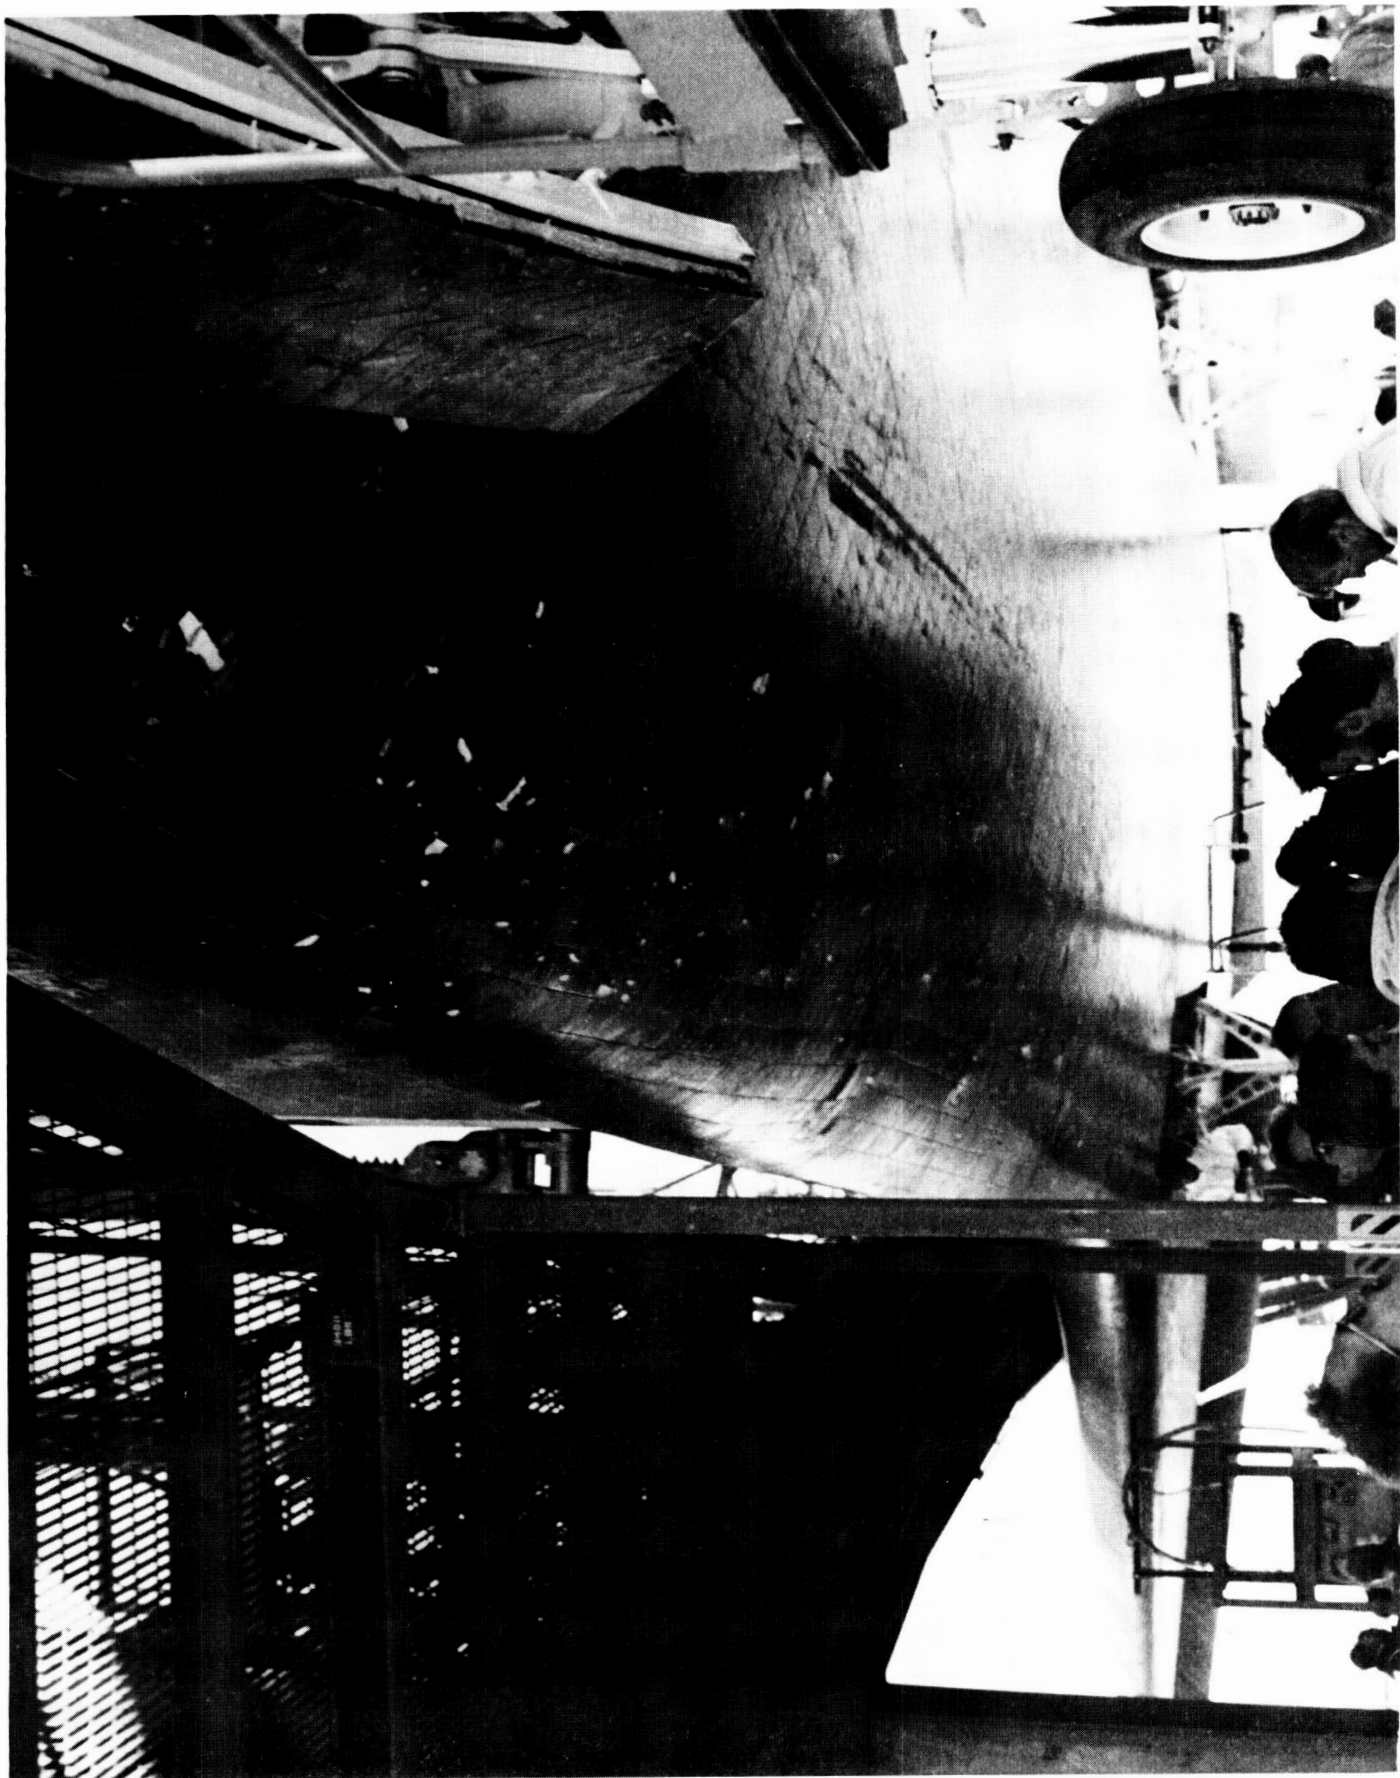
DEBRIS DAMAGE CONCENTRATION AROUND MISSING
TILE ON RH FUSELAGE FORWARD LOWER SURFACE

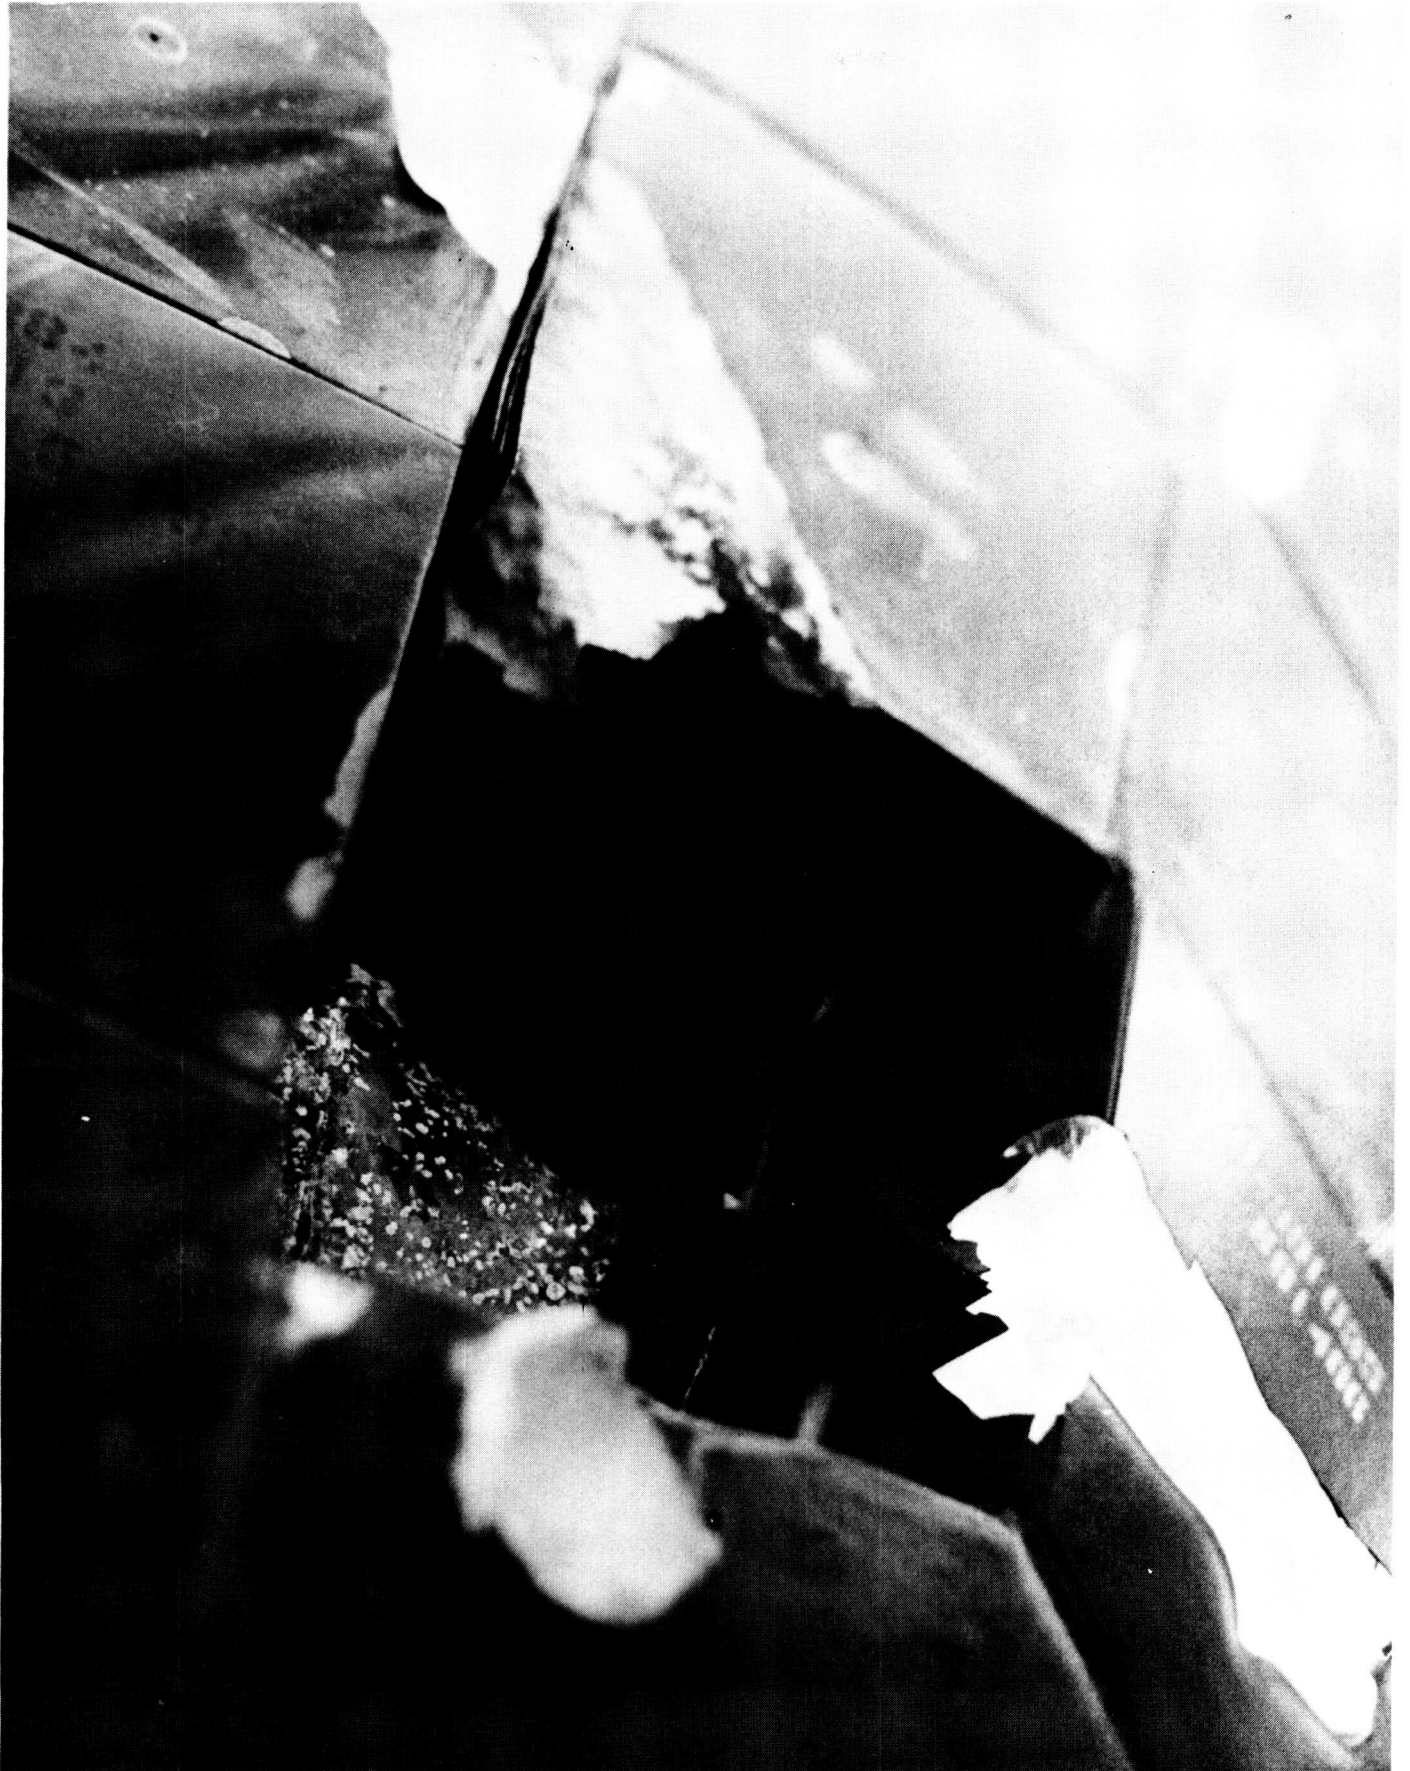
CHARRED SIP AND METAL SUBSTRATE IN CAVITY OF MISSING
TILE SHOW EFFECTS OF REENTRY HEATING

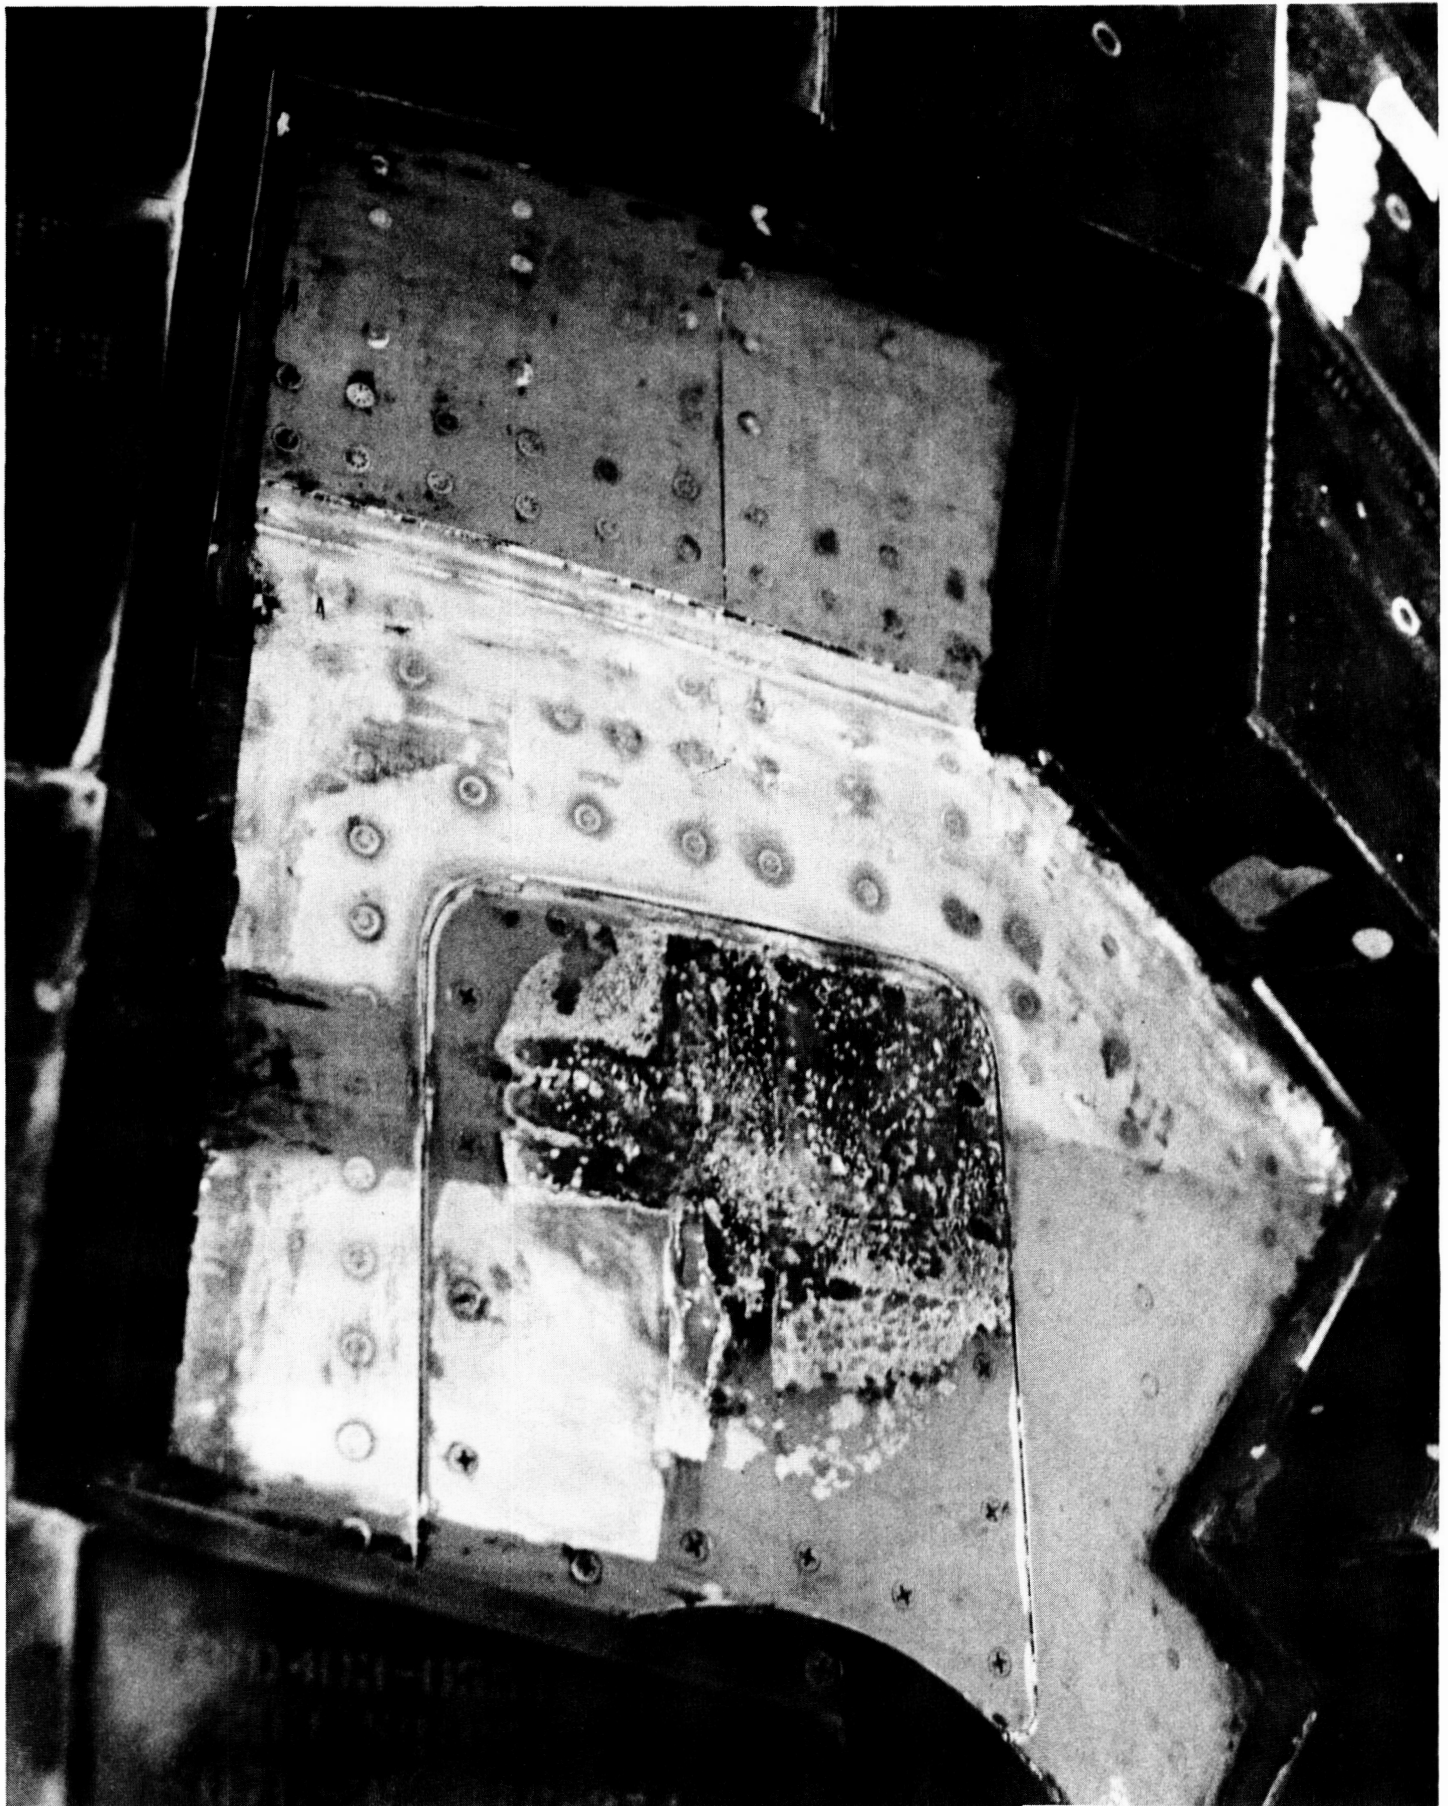
DAMAGED TILES REMOVED PRIOR TO FERRY FLIGHT. SCOPE OF
REENTRY HEATING DAMAGE IS VISIBLE ON L-BAND ANTENNA DOOR

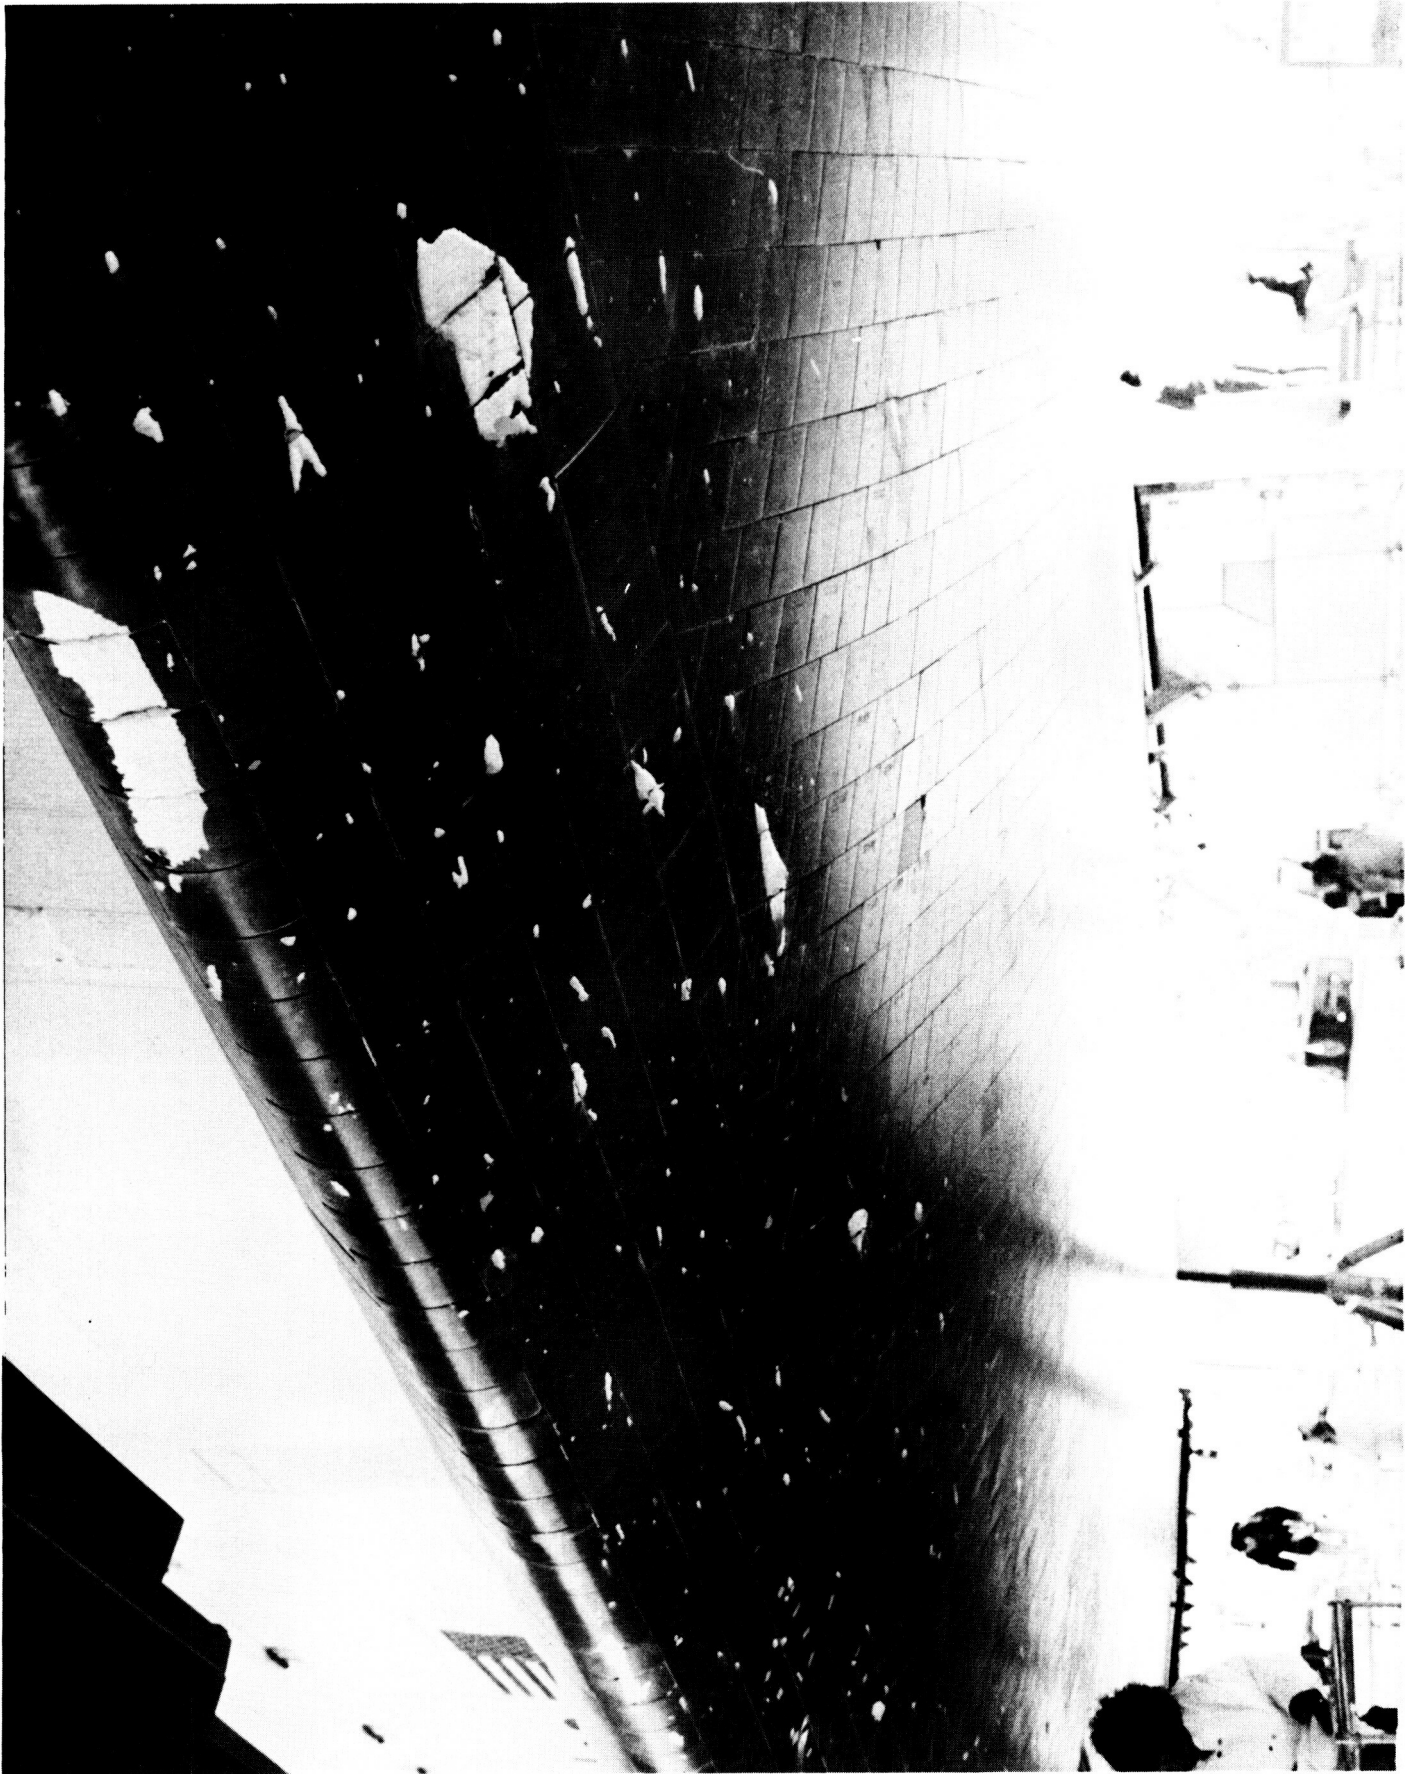
WIDE, SHALLOW TILE COATING DAMAGE AND LONG, DEEP
TILE GOUGES ON RH CHINE AND FORWARD LOWER FUSELAGE

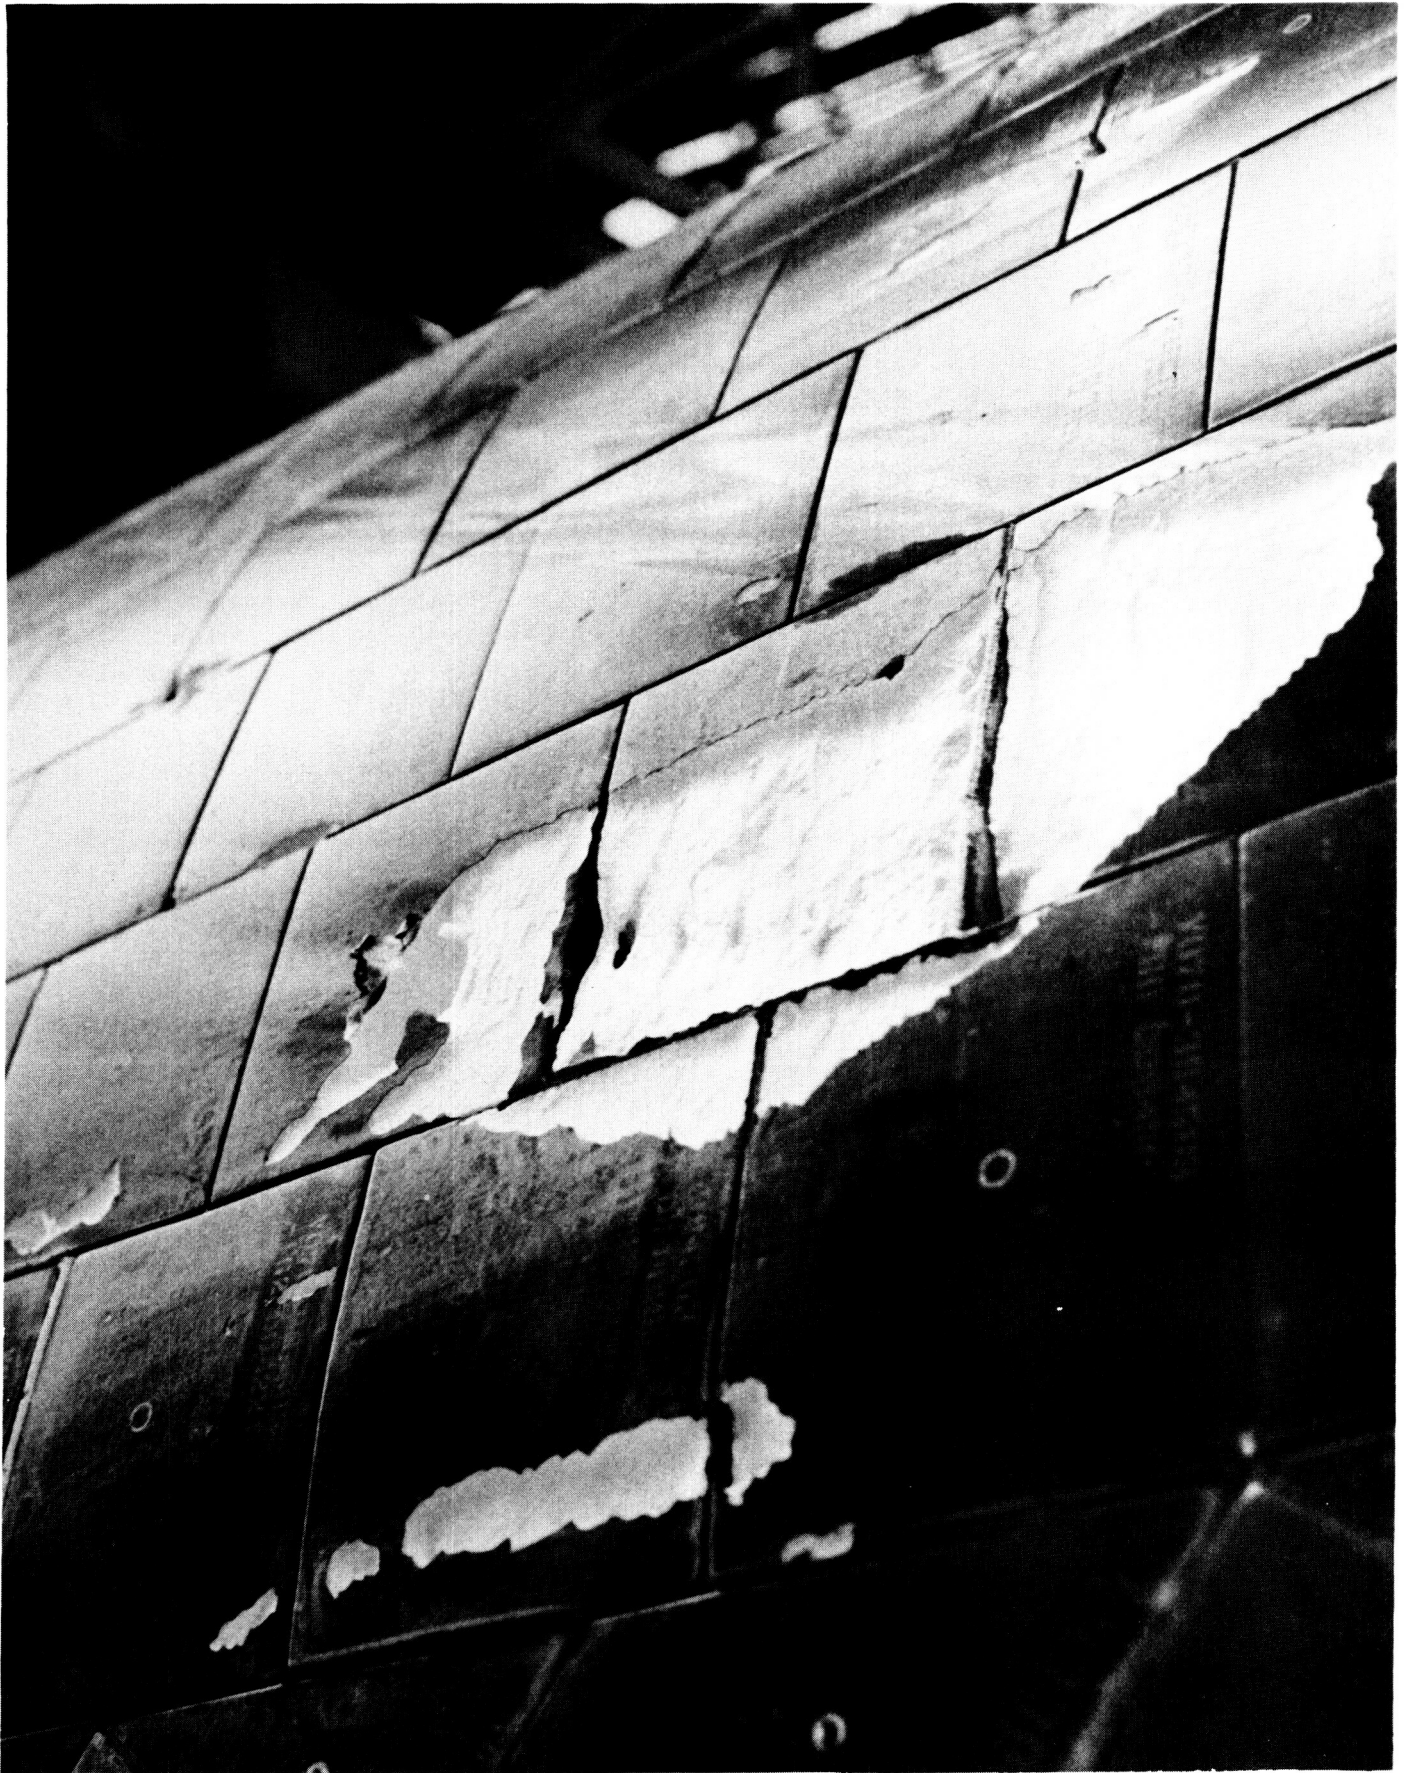
LARGE DAMAGE SITE INVOLVING 5 TILES ON RH CHINE HAS
BEEN ERODED AND REGLAZED DUE TO REENTRY HEATING.

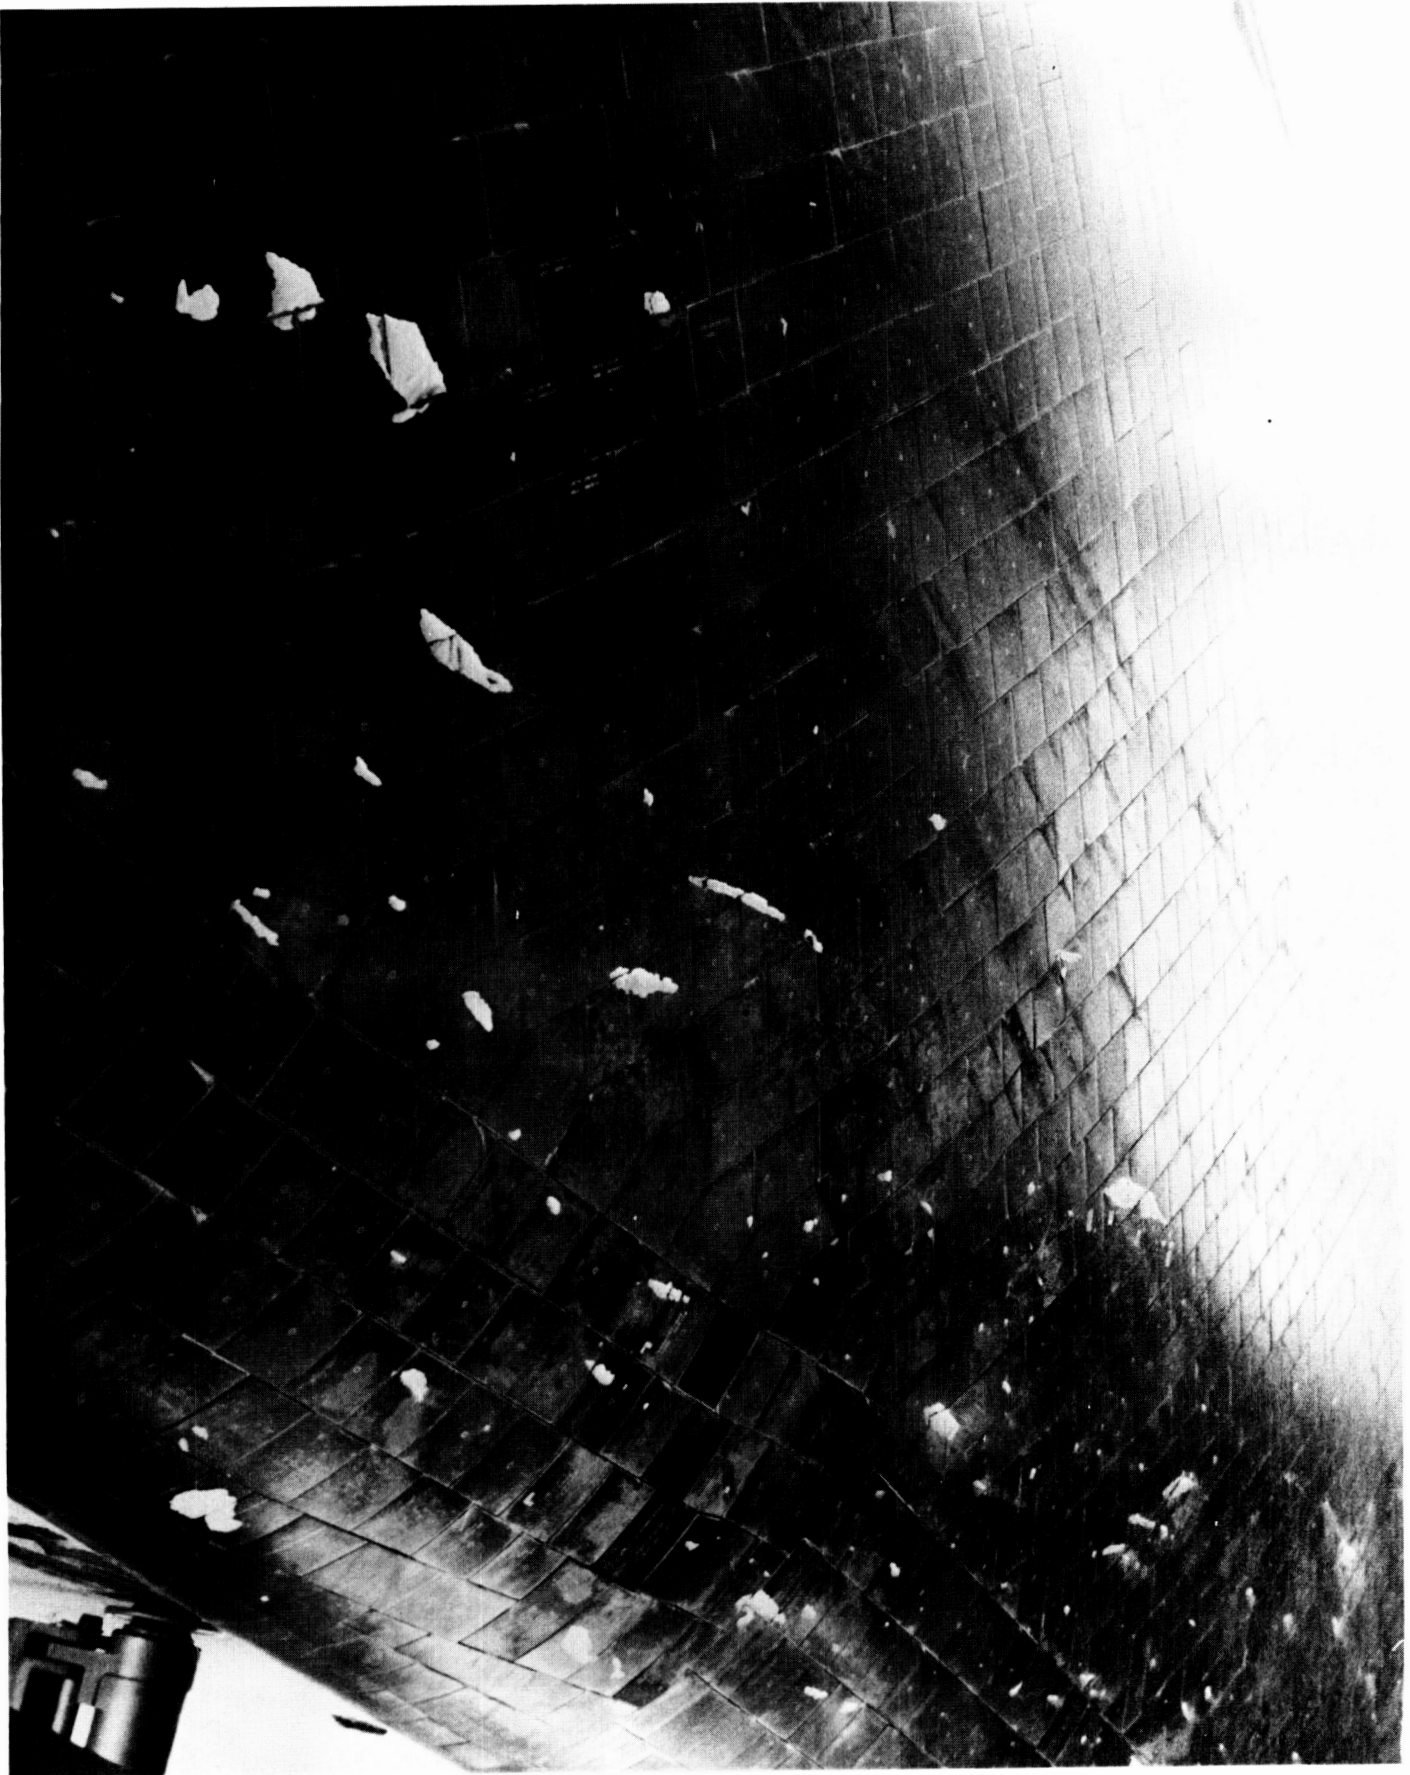
COMBINATION OF SHALLOW AND DEEP TILE
PENETRATIONS ON RH LOWER MID-FUSELAGE
